Marine Newslink

DECEMBER 2020

Molten Aluminium

ALUMINIUM

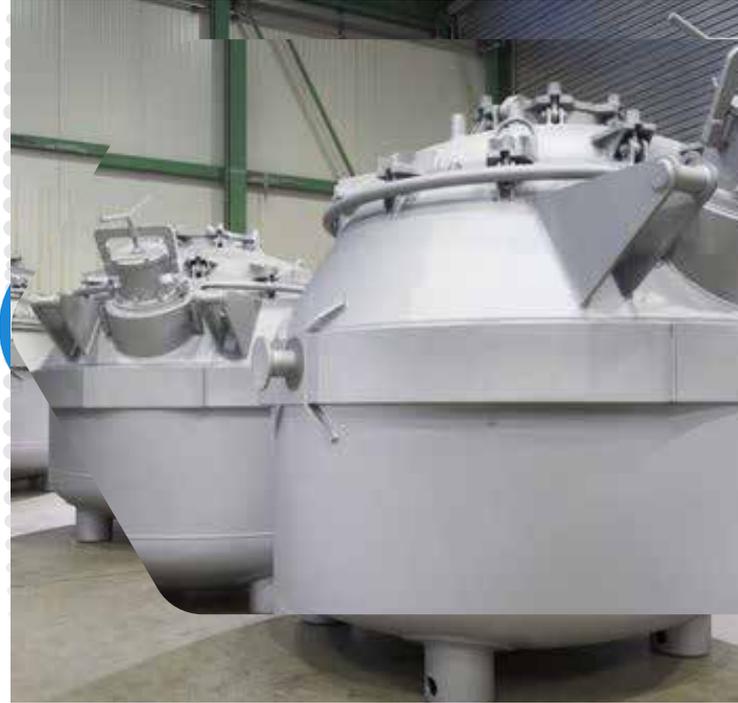
the refractory selection and design of the molten Aluminium transportation ladles are key issues. A molten Aluminium transportation crucible comprises of a dense refractory for Aluminium contact, an insulating layer to inhibit heat loss and metal freezing, a removable lid (where the metal is loaded) and a slide gate valve (where the metal is tapped at the customer furnaces trough). Thermal insulation of ladle is essential to save energy and provide high temperature, molten Aluminium to the customer.

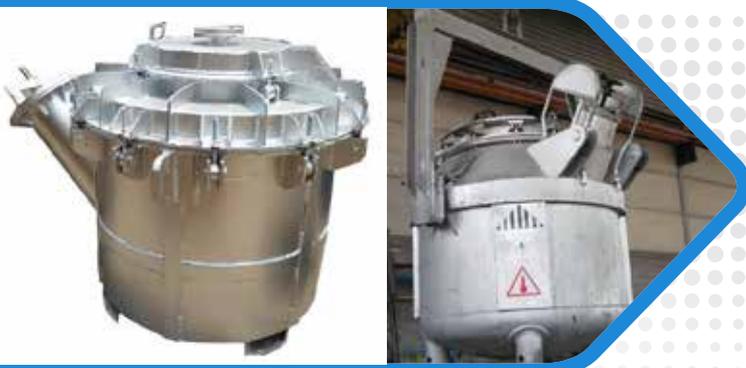
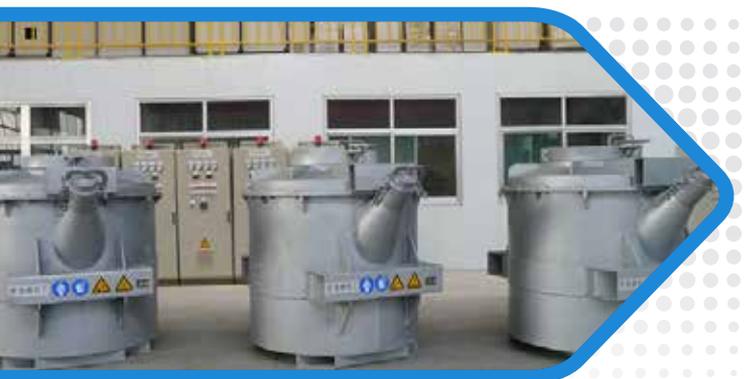
Among them, the first one is of utmost importance to ensure a suitable delivering temperature (reduce heat exchange between the refractory and the metal) and also to minimize the refractory damage by thermal shock. The pre-heating schedule is designed to provide time for gradual heating of the

refractory's internal lining surface, up to a temperature close to the molten metal. Afterwards, a soaking time is required in order to make sure that the crucible is close to the equilibrium condition and ready for Aluminium tapping. When this step is over, the molten metal is then loaded, and the crucible is placed on a truck. On the road, the temperature of the molten metal starts to decrease as heat is transferred from the metal to the refractory and to the environment.

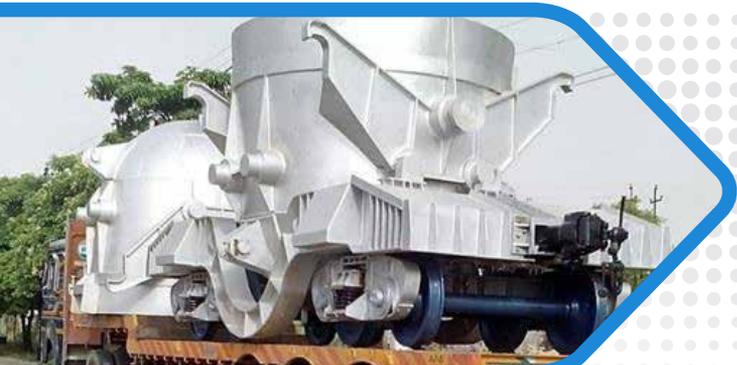
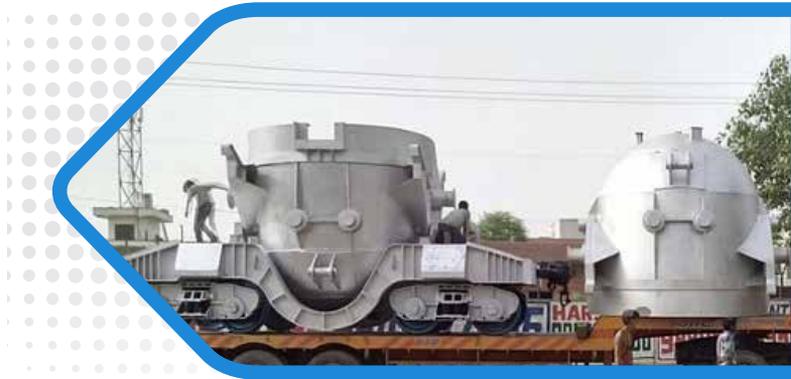
Transport of up to 800°C liquid Aluminium in special crucibles, from the production sites of high-profile Aluminium producers and smelting plants. Liquid Aluminium customers are predominantly manufacturers of car and aircraft components.

Custom-built refractory crucibles carrying molten Aluminium are loaded on flat-bed trailers but can be loaded on any adequate carrying capacity truck. The crucibles must be duly lashed, using strong metal chains & such lashing also accounted for exigencies of speed and braking of carrying vehicle. Select transport companies that specialise in carrying such cargoes, have requisite experience over different geographies, in the intended routes and have exposure to carrying such cargoes in all-weather conditions.

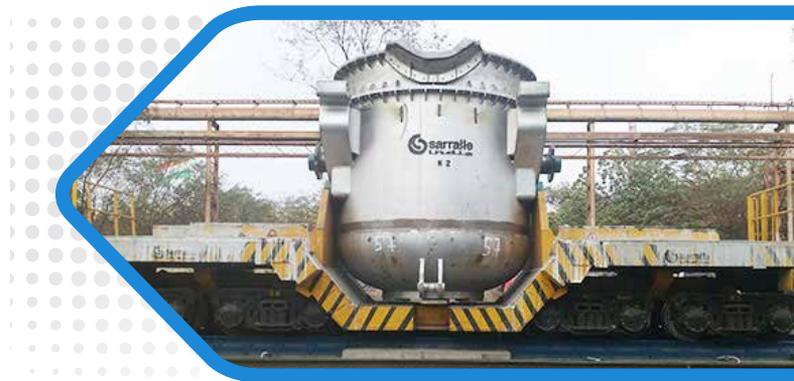
For even higher quantities, Rail-mounted ladles with complete mechanism to empty them at destination, are better options and should be the preferred mode, wherever possible. The rail transportation of such cargo is considered much safer than road transportation.

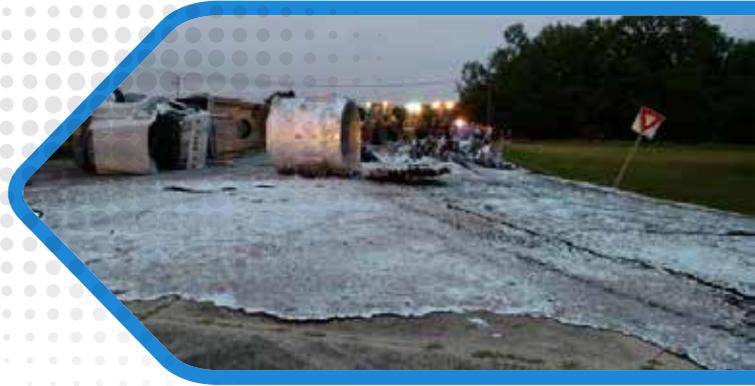
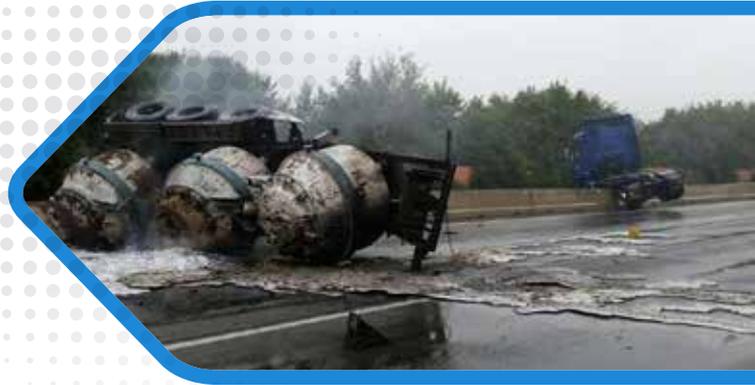
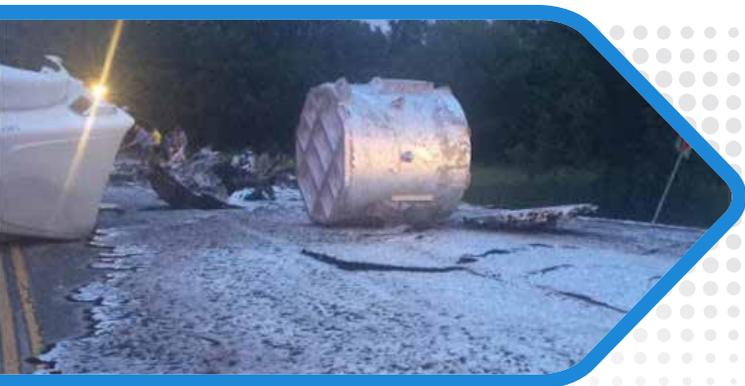
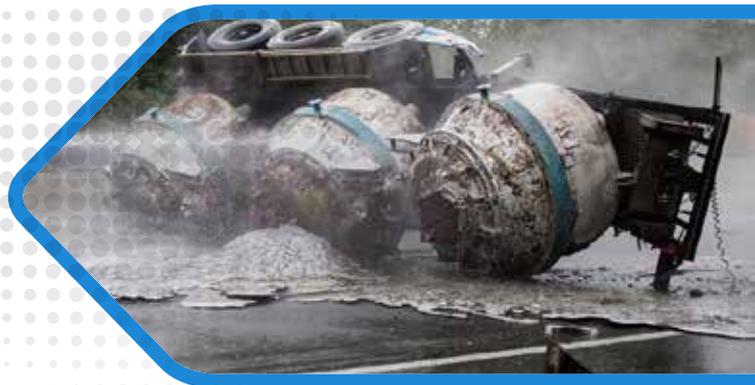
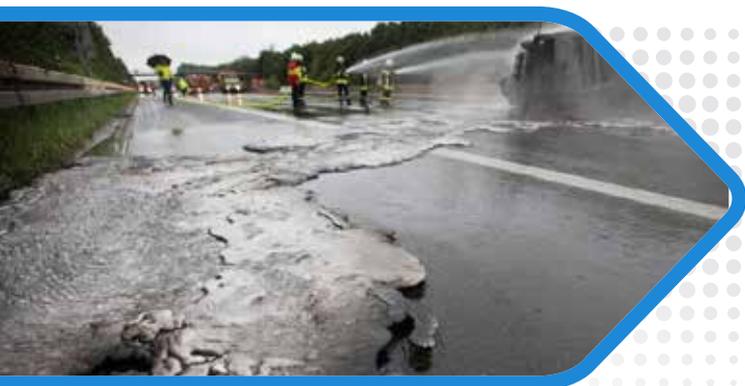
MOLTEN ALUMINIUM SPILL

PHOTOS OF THE MONTH
